## Health & Safety Assessment

### **Pavilion Building** **Badbury View Road** **Corfe Mullen** **BH21 3HU**

**Date of Site Visit: 24/05/2022**

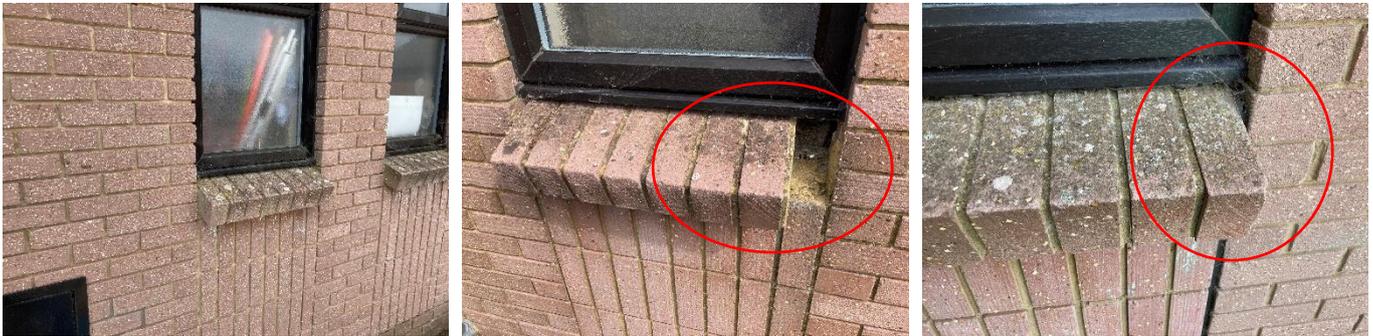
- A number of (external) brick windowsills are defective. Bricks are loose and can be easily prised loose. There is a risk that a child could accidentally pull a brick loose, causing it to fall and injure them.

- 6.1.1. A number of brick windowsills are defective. Bricks are loose and can be easily prised loose. There is a risk that a child could accidentally pull a brick loose, causing it to fall and injure them.

**UNACCEPTABLE**

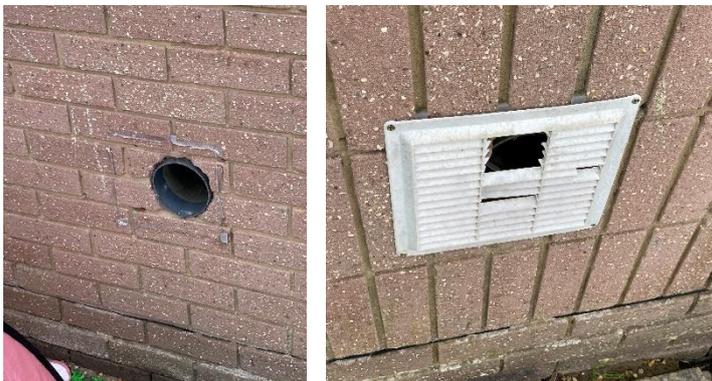
- 6.1.3. Exposure of “small hands” to defective vent covers - There were two vents in the paved play area where small children could be exposed to sharp edges from unguarded vent pipes, and as they are at child height, may reach into the pipes themselves.

**UNACCEPTABLE**

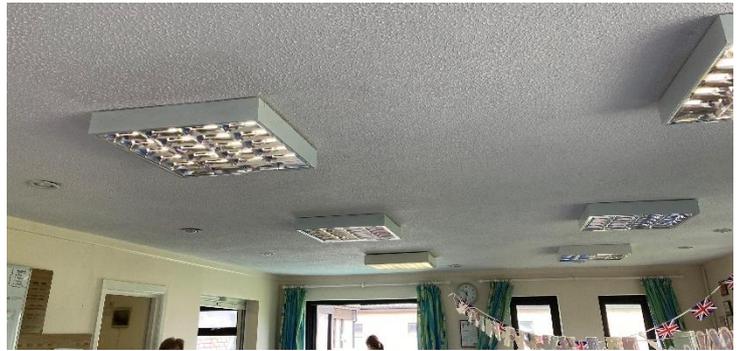
- 6.1.5. Emergency lighting in the area occupied by the nursery – there is one emergency light in the kitchen, however at the time of the inspection it was not possible to determine if there were any in the main room. Normally there is a small indicator light within the light fitting itself to show that it is a

'maintained' light<sup>1</sup>. Similarly, there was no list of emergency light units in the fire log. In the event of a power cut happening during hours of darkness this would be a matter of concern. The nursery's hours of operation are listed as 8am-6pm.

**FURTHER INVESTIGATION ADVISED**

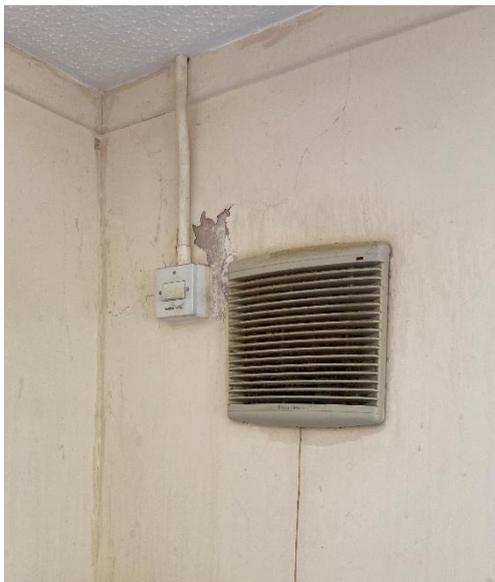
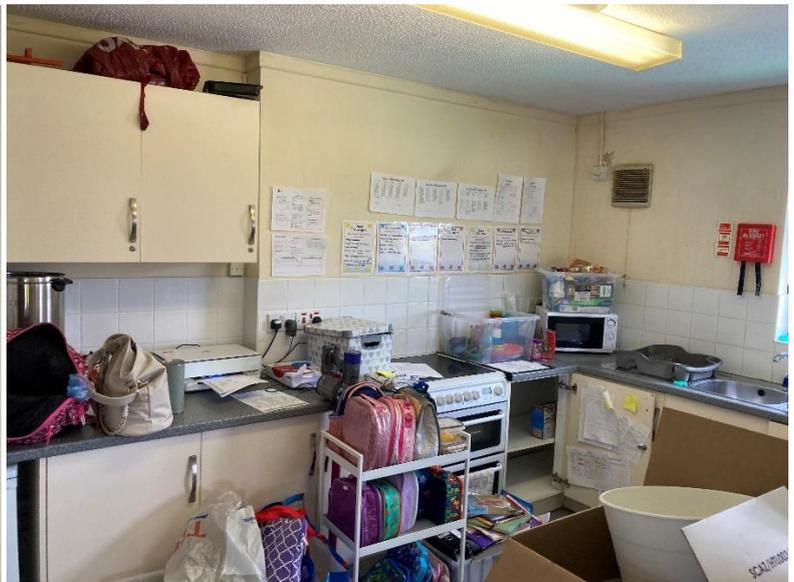
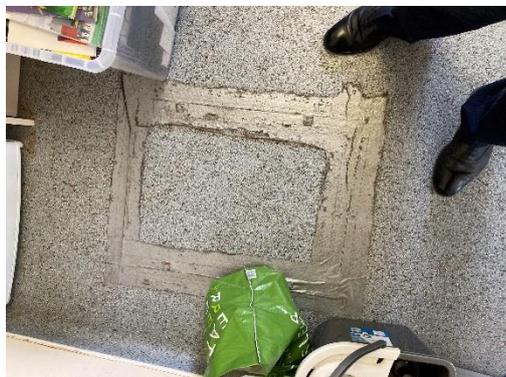
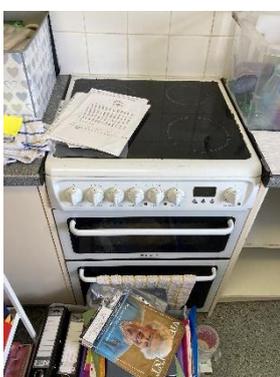
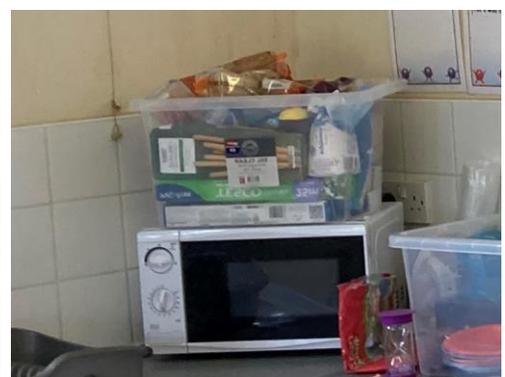
6.1.6. Kitchen Hygiene – The kitchen has a number of hygiene issues, and at the time of the investigation there were concerns about the state of decoration, the effectiveness of the extractor fan, the condition of the kitchen floor surface and malodour within the microwave oven. A review of the condition of the paintwork, extractor, microwave and floor surface is recommended.

**UNACCEPTABLE**

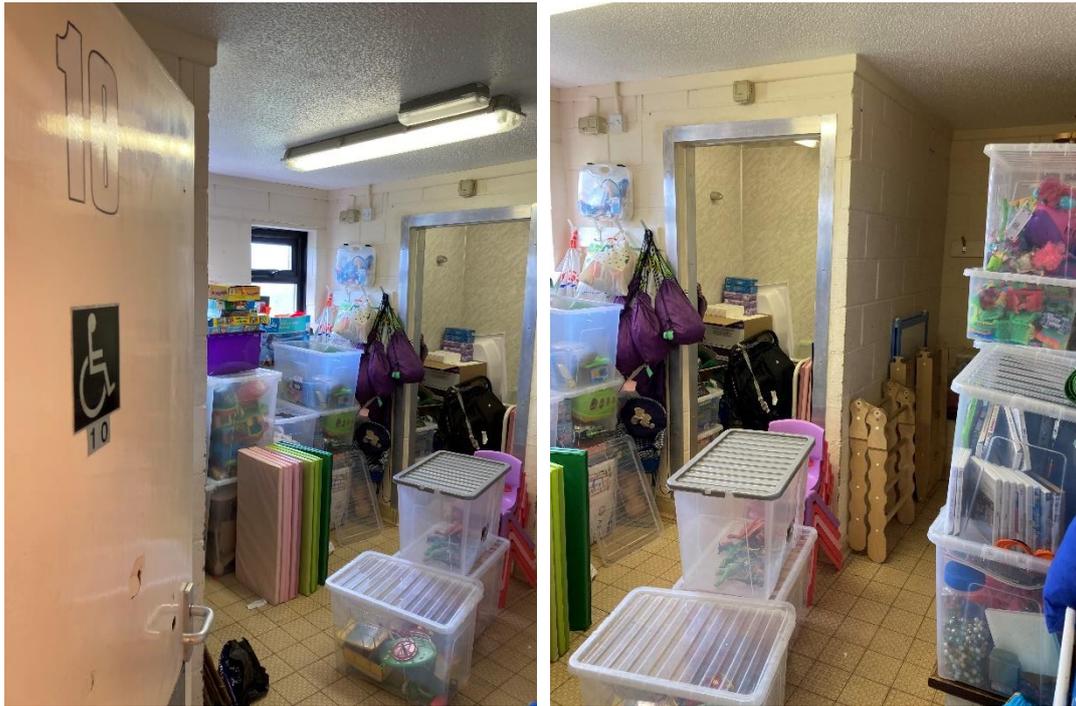
6.1.7. Storage space for nursery equipment – Room 10 is a decommissioned disabled changing room. There is no smoke detection in the room, and it was not clear at the time of the inspection if reasonable adjustment had been made elsewhere for the needs of disabled visitors.

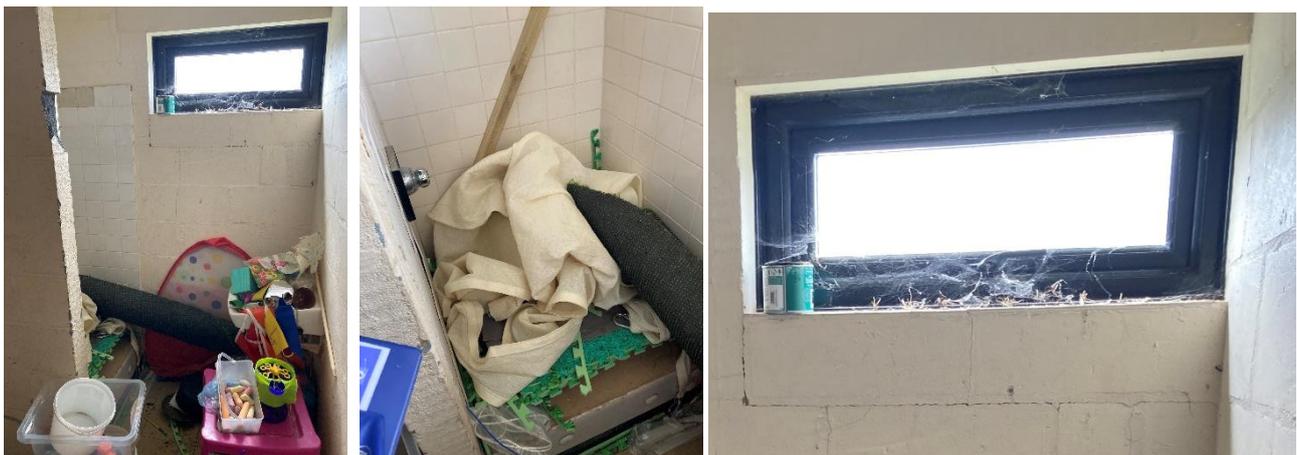
In addition, one of the other changing rooms had been given over to storage of toys and other debris. From a fire, housekeeping and hygiene perspective this is not a desirable situation.

**OBSERVATION**

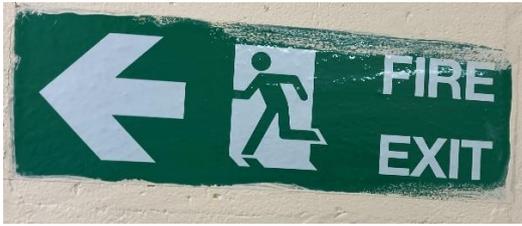
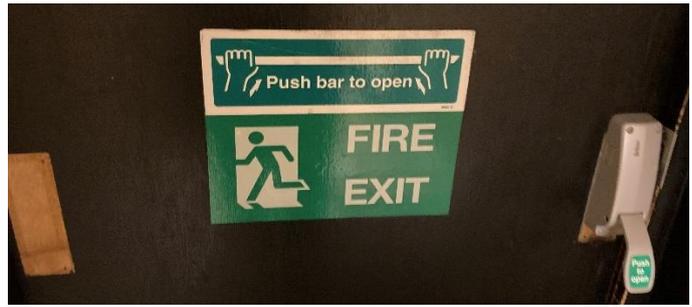
Fire signage in the building is inadequate and needs to be improved. Fire extinguishers and fire routes are not sufficiently signposted (e.g. the passageway to the West exit, near changing room 1, was not correctly signposted on the other side of the internal inter-connecting door). One fire sign has been partially painted over and should be replaced. One of the fire exits says "push bar to open" but the bar has been removed.

It should be possible to stand in the corridor and always see a fire exit sign, this was not always the case. In short, fire signage is inadequate.

**UNACCEPTABLE**

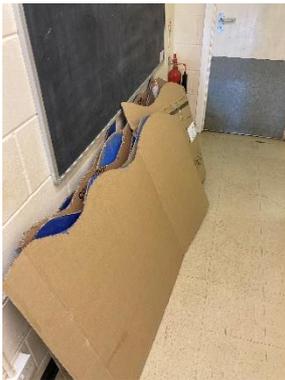
**UNACCEPTABLE**

The cardboard being stored in the corridor, which is a fire-protected area, should be moved to a designated storeroom, or disposed of. The corridors should all be kept clear of combustible material, and all internal fire doors kept closed.

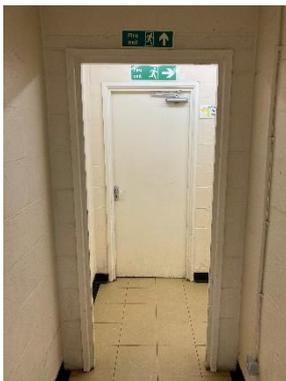
The fire door outside the ladies' toilets should be replaced. The door has been removed, and therefore the corridor's fire protection has been compromised.

**UNACCEPTABLE**

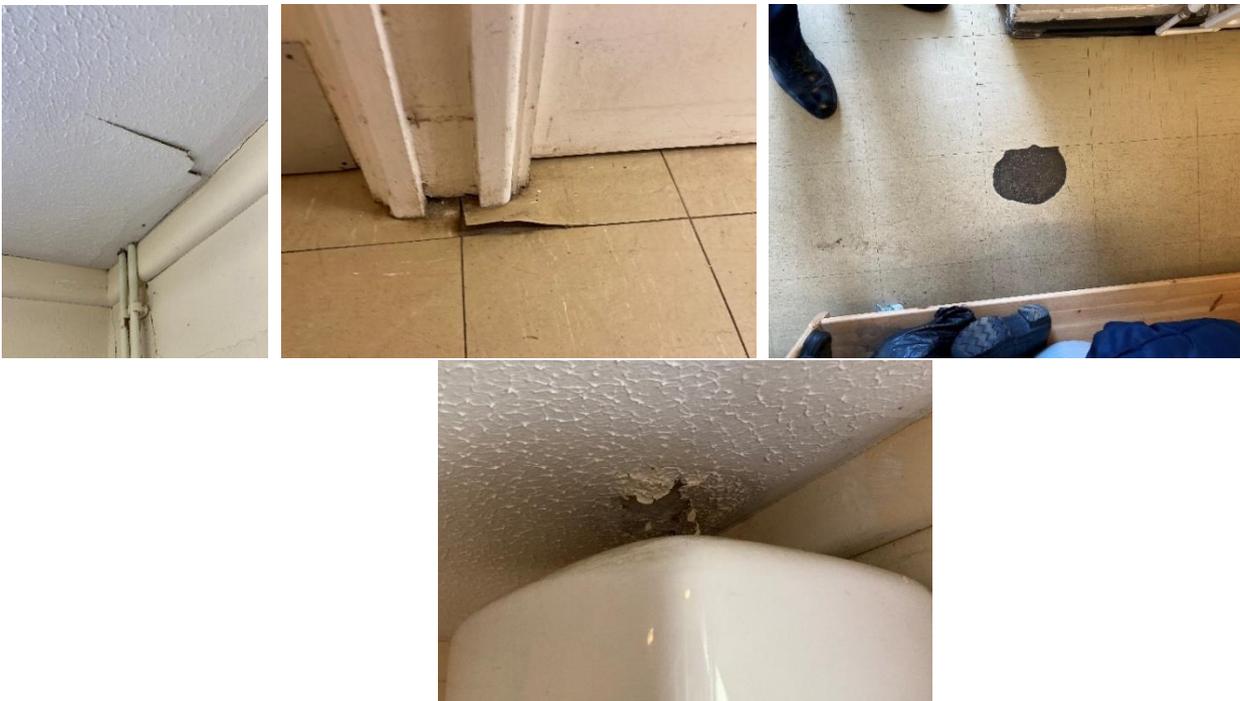
- 6.5.1. Note - This inspection did not include an intrusive inspection of floors, ceilings and walls. However, there was no asbestos register available at the time, so it was not possible to determine the presence or otherwise of asbestos containing materials.
- 6.5.2. 'Vinyl' floor tiles are present, some in very poor condition, which looked to be of the type that may contain asbestos. This should be explored, and a management plan put in place.
- 6.5.3. Textured ceiling coating was present ('Artex') which was known to be asbestos containing at the time this building was constructed. This is relevant in that so many of the ceilings within the building are in a poor state of maintenance, and it may be decided that the paint should be scraped off and replaced. This must not happen until an asbestos check has been undertaken.

**FURTHER INVESTIGATION ADVISED**

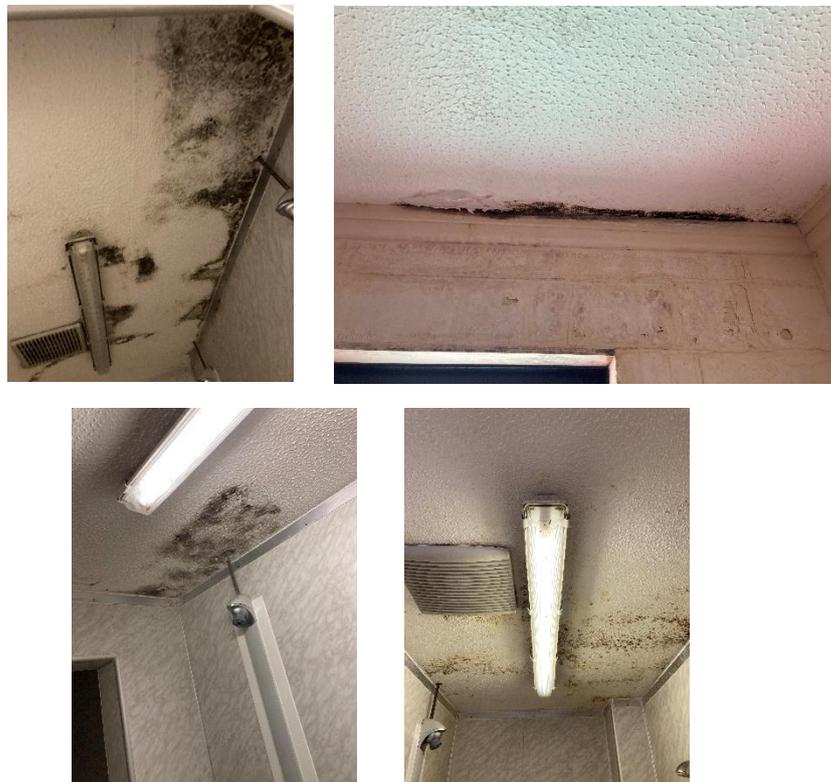
At the time of the inspection, many of the air extraction units were either not working or had been set to the wrong automatic setting. Consequently, the changing rooms, in general, smelt unhygienic (changing room 7 in particular) and there are numerous examples of mildew owing to lack of effective ventilation.

**UNACCEPTABLE**

It is recommended that an engineer who understands the requirements of CIBSE Guide B; section 2.3.21 (practical design of heating, ventilation and air conditioning systems for sports and leisure centres) should investigate and install, reset or maintain appropriate ventilation units.

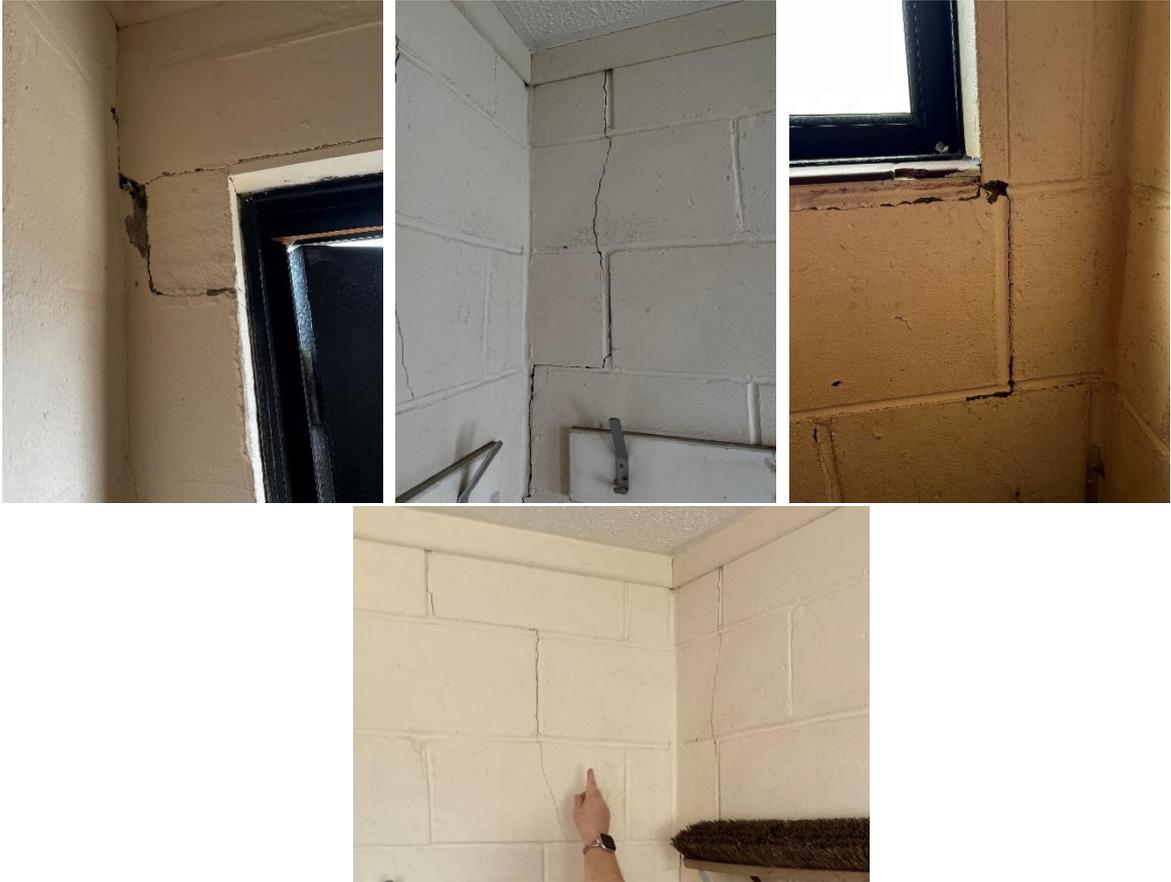
6.10.1. **Soundness of the walls** – There were a number of instances where cracking in the walls was seen. This report is not a structural survey; however, these cracks were consistent with minor building subsidence.

**FURTHER INVESTIGATION ADVISED**

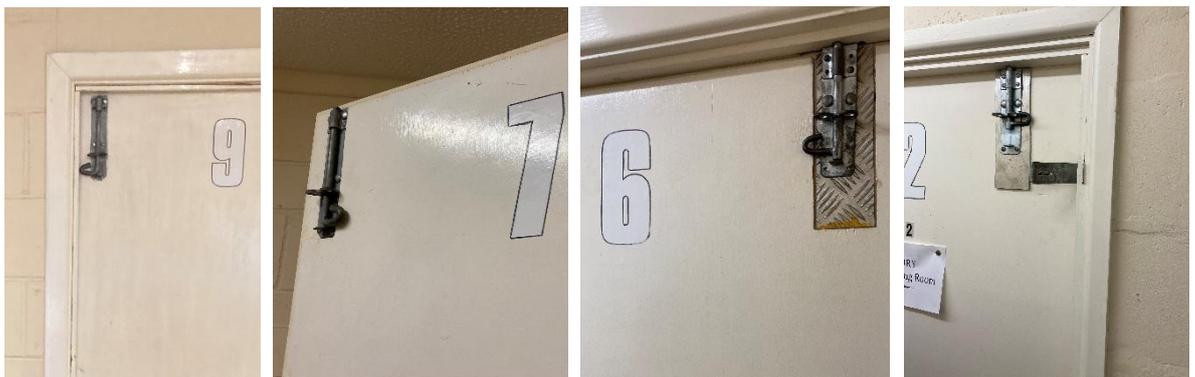
6.10.2. **Locks to the changing rooms** – Each of the changing rooms has a door bolt, allowing the door to be locked from the outside. Consequently, any person inside the changing room can be trapped, either inadvertently or through horseplay. Given the inadequacy of emergency lighting and fire detection/alarms these bolts **must be removed on safety grounds**. If the purpose of the bolts is to provide out-of-hours security assurance, to prevent the ingress of intruders coming through a window, then an alternative method must be employed.

It must not be possible to lock any person in the changing rooms (apart from personal safety, there is an offence known as ‘false imprisonment at common law by direct means’).

**UNACCEPTABLE**

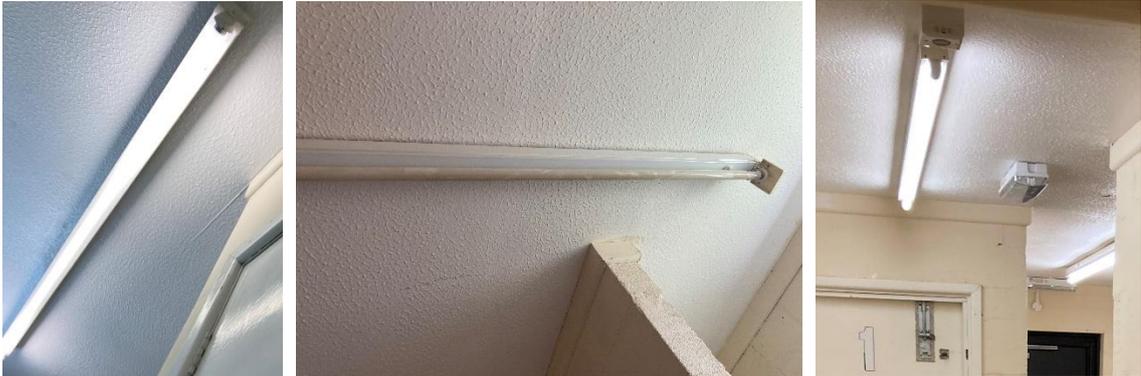
Several the fluorescent light fittings have lost their covers. Therefore, the light tubes are exposed. Given the nature of this building, it is foreseeable that the light tube could be struck and shatter, releasing broken glass into the changing rooms.

**UNACCEPTABLE**

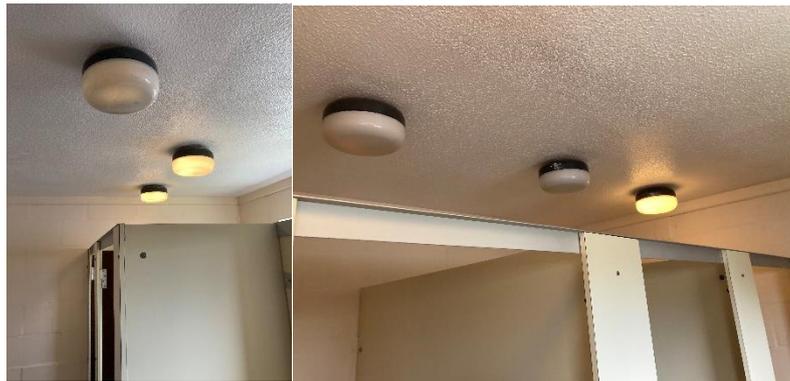
It was not apparent if there is an inspection regimen for the light fittings, however at the time of the inspection a few of the lights were not working. In addition, although some of the lights were on a sensor, these did not always work correctly. In particular, the light in changing room 7 switched itself off when the room was occupied. The lack of any other lighting means that any occupants could be left in the dark.

**UNACCEPTABLE**
