**NOTICE OF NEXT COUNCIL MEETING**

Meeting of... **COMMUNITY SERVICES COMMITTEE**  
Time... **19:00**  
Date... **Tuesday 11 February 2025**  
Place... **Small Hall of the Village Hall, Towers Way, Corfe Mullen**

**Minutes of the Community Services Committee held on Tuesday 12 November 2024  
at 19:00 in the Small Hall of the Village Hall, Towers Way, Corfe Mullen**

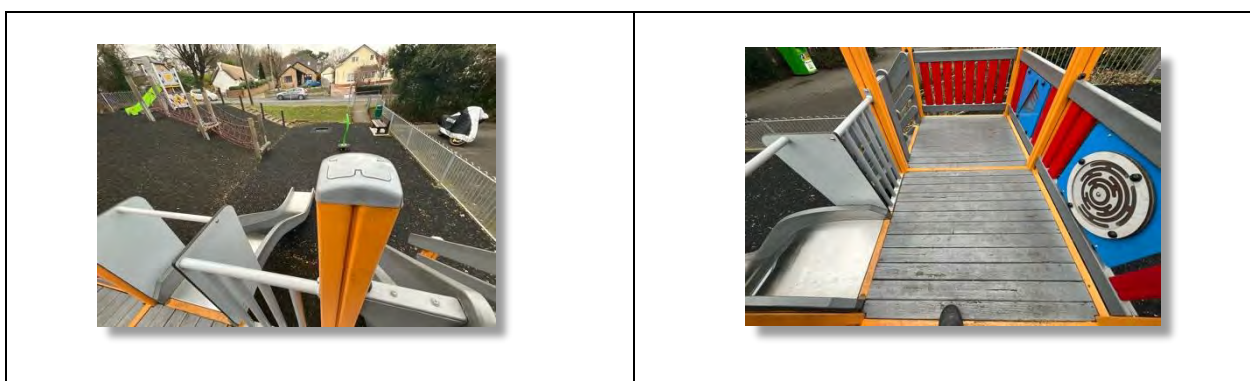
Item	OK	Action Required	N/A	Comments
Are timber surfaces damaged, splintered or deteriorating?		✓		<b>Observations:</b> Areas of wooden support displays cracks. <b>Recommendations:</b> Monitor the cracks for movement and replace d. See photo HPA003

Are ladder rungs and handholds in good order?	✓			Ladder rungs and handholds were in good condition.
Are all bolts secure and tight?		✓		<b>Observations:</b> Securing mounts for the fort top rails were seen to be loose, split and have moved. <b>Recommendation:</b> Ensure all loose horizontal to vertical wooden connectors are tightened or replaced. See photo HPA004
Are hangers for swings firmly in place and showing no signs of wear?			✓	
Is all equipment structurally sound?	✓			When inspected I found no structural concerns.
Are swing seats in good condition?			✓	
Are chains and moving parts in good condition, links showing no signs of wear with connectors properly fitted and secure?			✓	
Are metal structures free from corrosion and damage?	✓			There were no signs of significant corrosion.
Are ground supports secure?	✓			Equipment is firmly anchored to the ground.
Are floors and platforms in good condition and secure?		✓		<b>Observations:</b> While the platforms have received a coat of paint, they still exhibit signs of fatigue, notably, the drop of the platform, which has produced a significant drop from the supporting crossmember to the platform itself. <b>Recommendations:</b> Replace the fatigued elements to maintain the integrity and profile of the platform. See photo HPA005

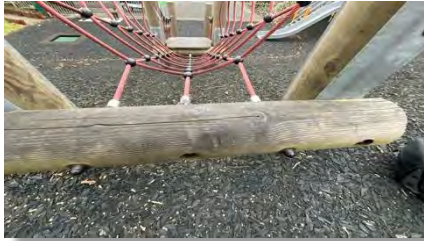
### Playground equipment: Rope Bridge

Item	OK	Action Required	N/A	Comments
Are timber surfaces damaged, splintered or deteriorating?		✓		<b>Observations:</b> Some of the supporting elements display cracks running their length. <b>Recommendations:</b> Supporting elements of wood must be inspected periodically to ensure these cracks do not open and reduce the integrity of the wood. See photo HPA006
Are ladder rungs and handholds in good order?	✓			Ladder rungs and handholds were in good condition.
Are all bolts secure and tight?	✓			All bolts viewed were tight. <b>Check manufacturers specifications as middle mounts may need G-Tub screws?</b>
Are hangers for swings firmly in place and showing no signs of wear?			✓	
Is all equipment structurally sound?	✓			When inspected I found no structural concerns.
Are swing seats in good condition?			✓	
Are chains and moving parts in good condition, links showing no signs of wear with connectors properly fitted and secure?	✓			.

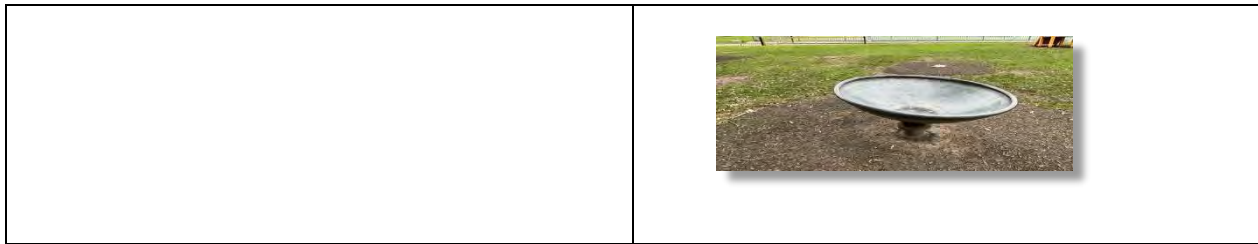
Item	OK	Action Required	N/A	Comments
Are timber surfaces damaged, splintered or deteriorating?			✓	
Are ladder rungs and handholds in good order?			✓	
Are all bolts secure and tight?	✓			All bolts viewed were tight and did not display signs of fatigue.
Are hangers for swings firmly in place and showing no signs of wear?			✓	
Is all equipment structurally sound?	✓			When inspected. I found no structural concerns or deviation from rotation route.
Are swing seats in good condition?			✓	
Are chains and moving parts in good condition, links showing no signs of wear with connectors properly fitted and secure?	✓			No visible signs of fatigue.
Are metal structures free from corrosion and damage?	✓			The supporting structure appears to be in good condition.
Are ground supports secure?	✓			Equipment is firmly anchored to the ground.
Are floors and platforms in good condition and secure?	✓			Seating bowl is in good condition with no sharp edges, slight surface rust.

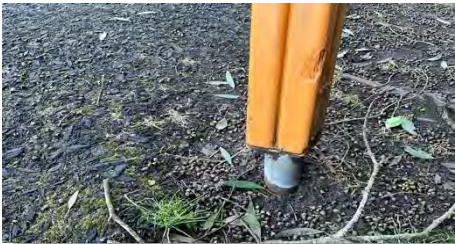
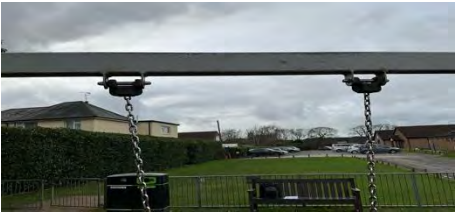
**Playground equipment: Swing Sets (X2)**

Item	OK	Action Required	N/A	Comments
Are timber surfaces damaged, splintered or deteriorating?		✓		<b>Observation:</b> Some of the timber on the swing sets is showing signs of fatigue and moisture ingress. <b>Recommendations:</b> Structure components that are showing signs of water ingress should be replaced. Structure components that are showing signs of fatigue should be refreshed with paint / sealant to stop further deterioration. See photos BVRG001a & BVRG001b
Are ladder rungs and handholds in good order?		✓		<b>Observation:</b> Some of the base bolts did not have their protective plastic caps on. <b>Recommendation:</b> Ensure all structural bolts have protective plastic caps fitted to stop corrosion from the elements.
Are all bolts secure and tight?	✓			All bolts viewed were tight.
Are hangers for swings firmly in place and showing no signs of wear?	✓			All hangers for the swings were securely attached and the bolts were not loose.

Is all equipment structurally sound?		✓		<b>Observation:</b> Due to the rotten nature of one of the vertical supports of one of the swings sets the structural stability of that swing set cannot be guaranteed. <b>Recommendation:</b> The wooden support must be tested to identify its structural capability or replaced. See Photos BVRG001a & BVRG001b
Are swing seats in good condition?	✓			The seats were in reasonably good condition.
Are chains and moving parts in good condition, links showing no signs of wear with		✓		<b>Observation:</b>

connectors properly fitted and secure?				Two of the connector bolts for the swings displayed signs of corrosion. <b>Recommendation:</b> Ensure all swing connector bolts are checked for structural strength or replaced at the earliest opportunity. See photo BVRG002.
Are metal structures free from corrosion and damage?	✓			There were no signs of significant corrosion.
Are ground supports secure?	✓			Equipment is firmly anchored to the ground.
Are floors and platforms in good condition and secure?			✓	
Are play surfaces in good condition and free from weeds, rubbish, broken glass, algae, etc?	✓			No signs of wear below the seats.
Is the play surface under swings level and showing no signs of wear?			✓	Surface is in good condition.
Photographic evidence and Description Identification Number & Description			✓
