Minutes of the Community Services Committee held on Tuesday 12 September 2023 at 19:30 in the Small Hall of the Village Hall, Towers Way, Corfe Mullen

My observations, recommended actions and supporting photographs are listed in Appendices 1 to 3 below.

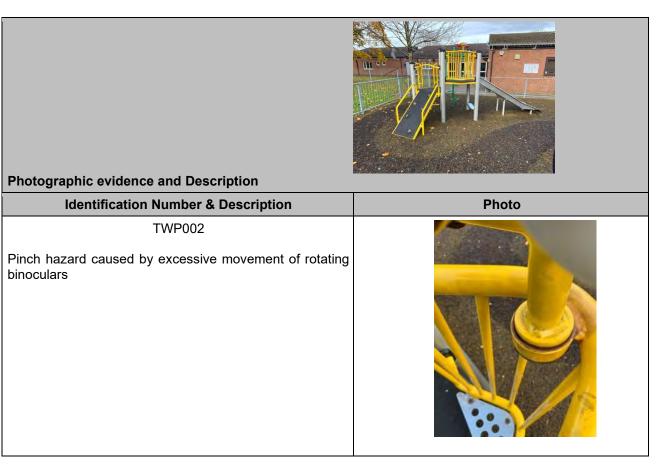
Item	ОК	Action required	N/A	Comments
Are timber surfaces damaged, splintered or deteriorating?			~	
Are ladder rungs and handholds in good order?	~			All handholds, guiderails, ramp, and slide were in good condition.
Are all bolts secure and tight?	~			All bolts when checked were tight.
Are hangers for swings firmly in place and showing no signs of wear?	~			The green frame to the rear was in a good state of repair.
Is all equipment structurally sound?	~			The equipment seemed structurally sound
Are swing seats in good condition?			~	
Are chains and moving parts in good condition, links showing no signs of wear with connectors properly fitted and secure?		~		Observation: The rotating observation binoculars moved freely; however, this has generated a pinch hazard for small fingers. Recommendation: Repair the rotating binoculars so the pinch hazard is removed or remove rotating binoculars. See picture TWP002
